**TRANSPORTATION RESEARCH CENTER**

**ON-SITE AIR BAG INVESTIGATION**

CASE NO. - 90-01  
FLEET - PRIVATE VEHICLE  
LOCATION - [REDACTED] INDIANA  
ACCIDENT DATE - [REDACTED] 1990

TRC/IU CASE NO. 90-01

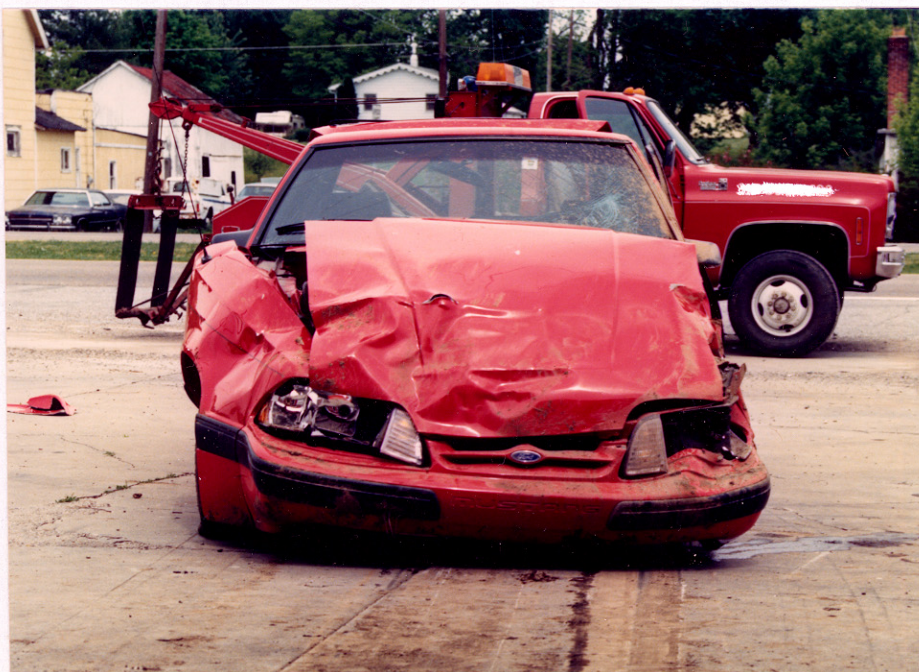
# 01 -- 1990  
Indiana  
TRC/IU: 90-01, Task: 0068  
Mustang frontal view

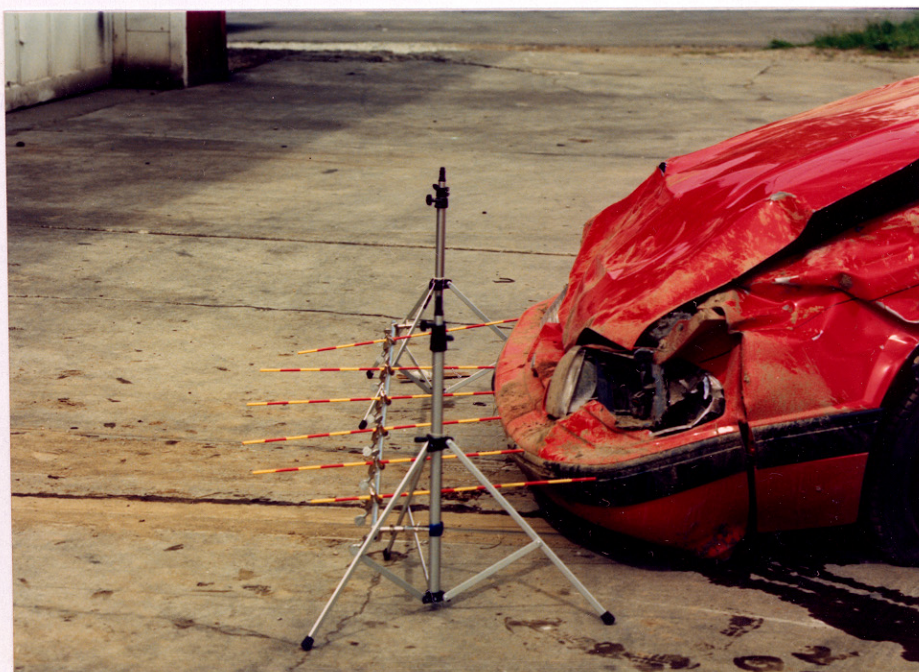
# 02 -- 1990  
Indiana  
TRC/IU: 90-01, Task: 0068  
Across front from left side

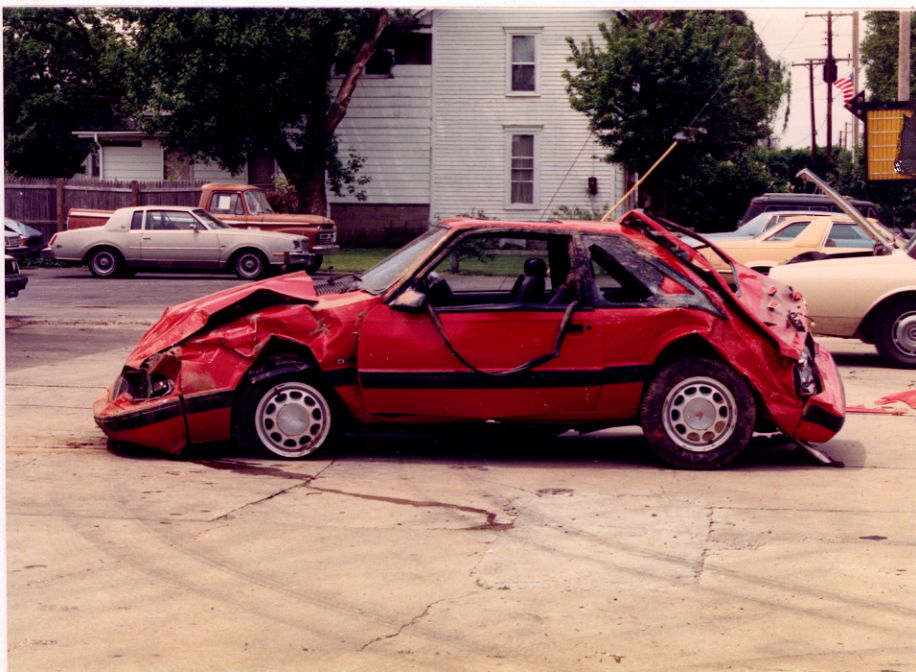
# 03 - 1990  
Indiana  
TRC/IU: 90-01, Task: 0068  
Full left side view

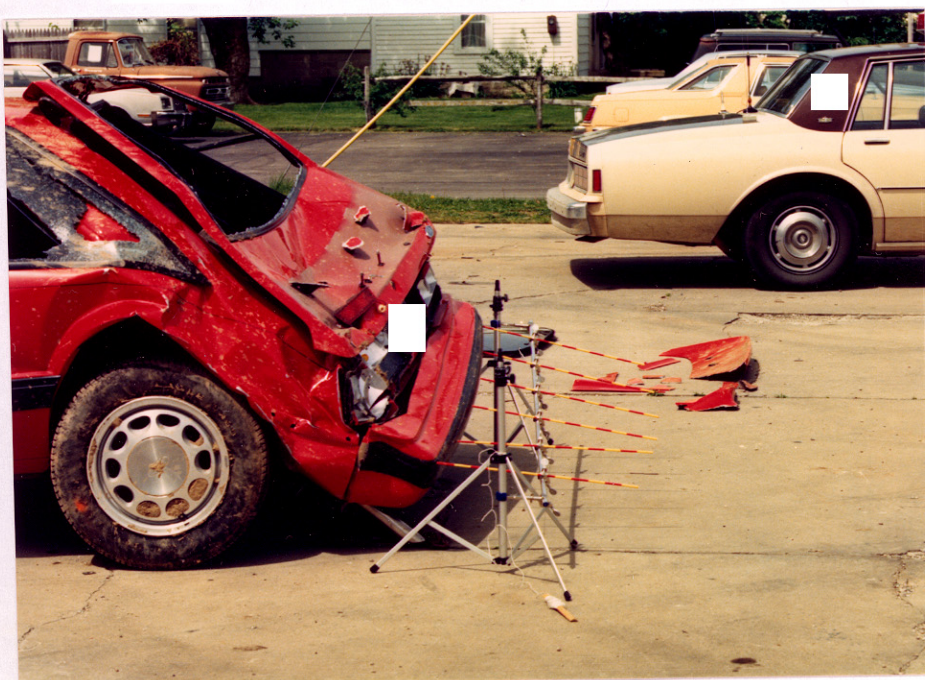
# 04 - 1990  
Indiana  
TRC/IU: 90-01, Task: 0068  
Across rear from left side

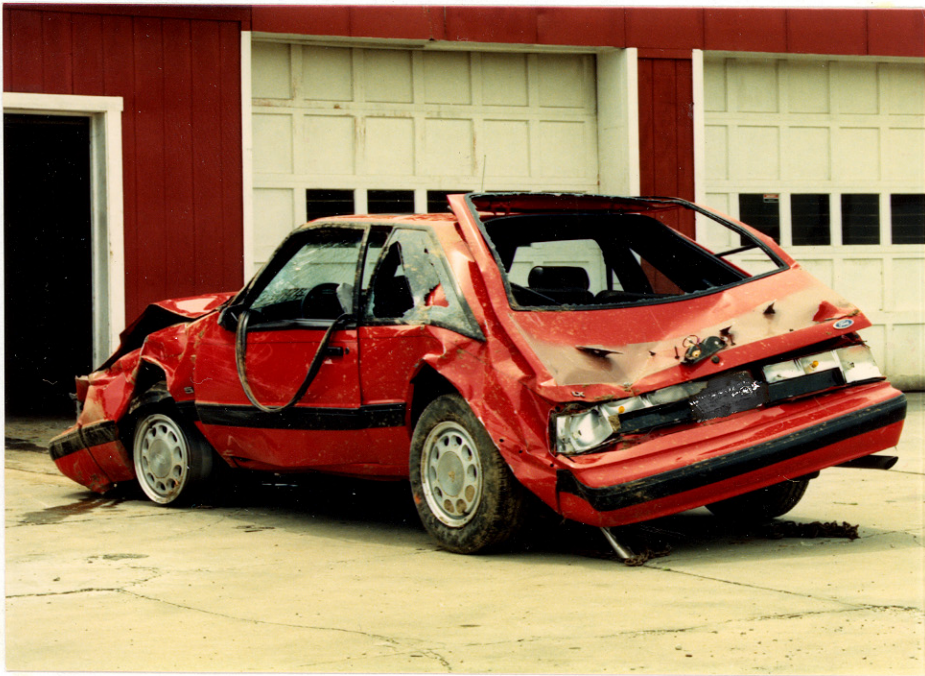
# 05 -- 1990  
Indiana  
TRC/IU: 90-01, Task: 0068  
Left rear rearside view

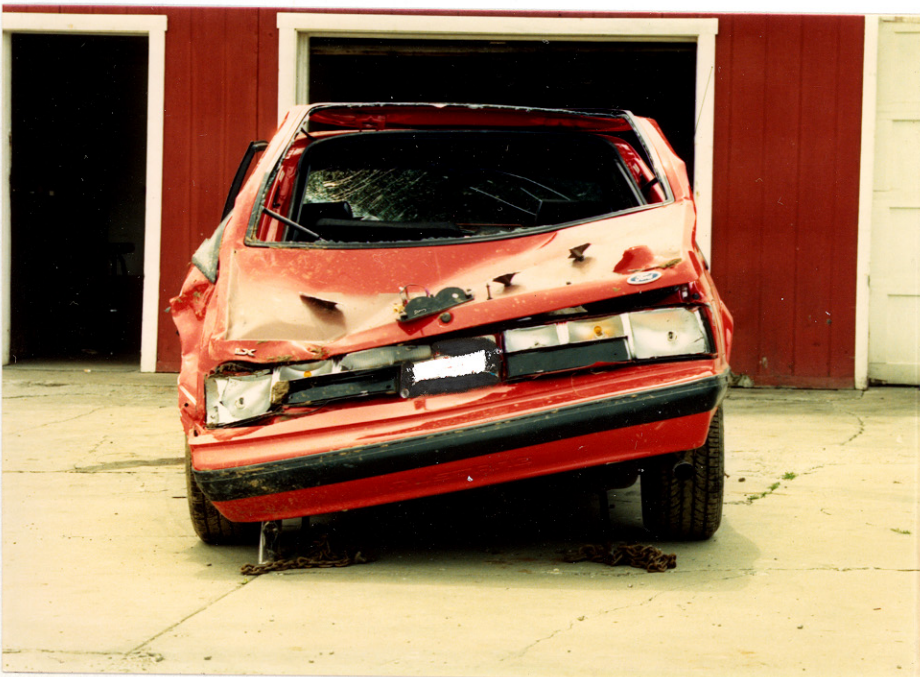
Note: Projected plane of primary contact was to the top, but the majority of damage was on the hood and hatch area.

Damaged Components: Windshield; left-front door glass; left-rear window glass; backlight glass; hood; front bumper; front headlights; front grille; left-front: fender, door, outside mirror; sunroof (missing); hatchback; right-front fender; rear spoiler (missing); rear taillights; rear bumper, left-rear quarter panel.

# 06 -- , 1990  
Indiana  
TRC/IU: 90-01, Task: 0068  
Damaged rear plane

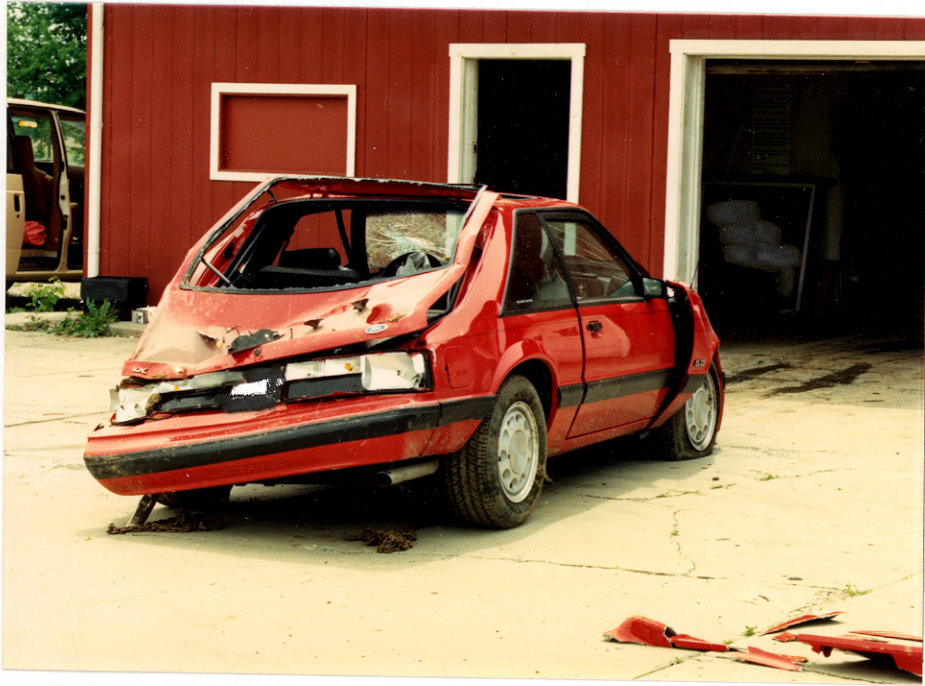
# 07 , 1990  
 Indiana  
 TRC/IU: 90-01, Task: 0068  
 Right rear rearside view

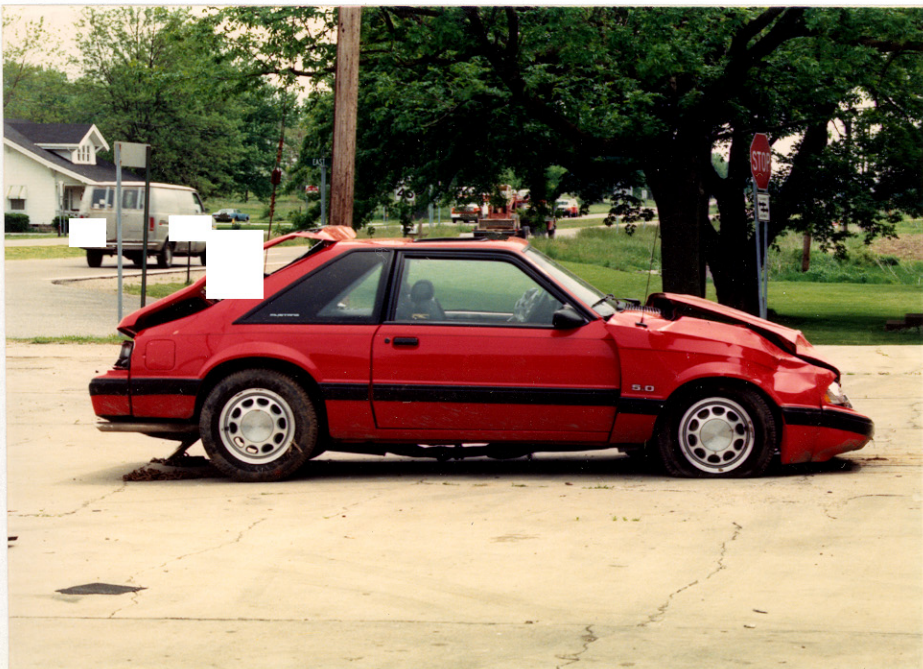
# 08 - 1990  
 Indiana  
 IRC/IU: 90-01, Task: 0068  
 Full right side view

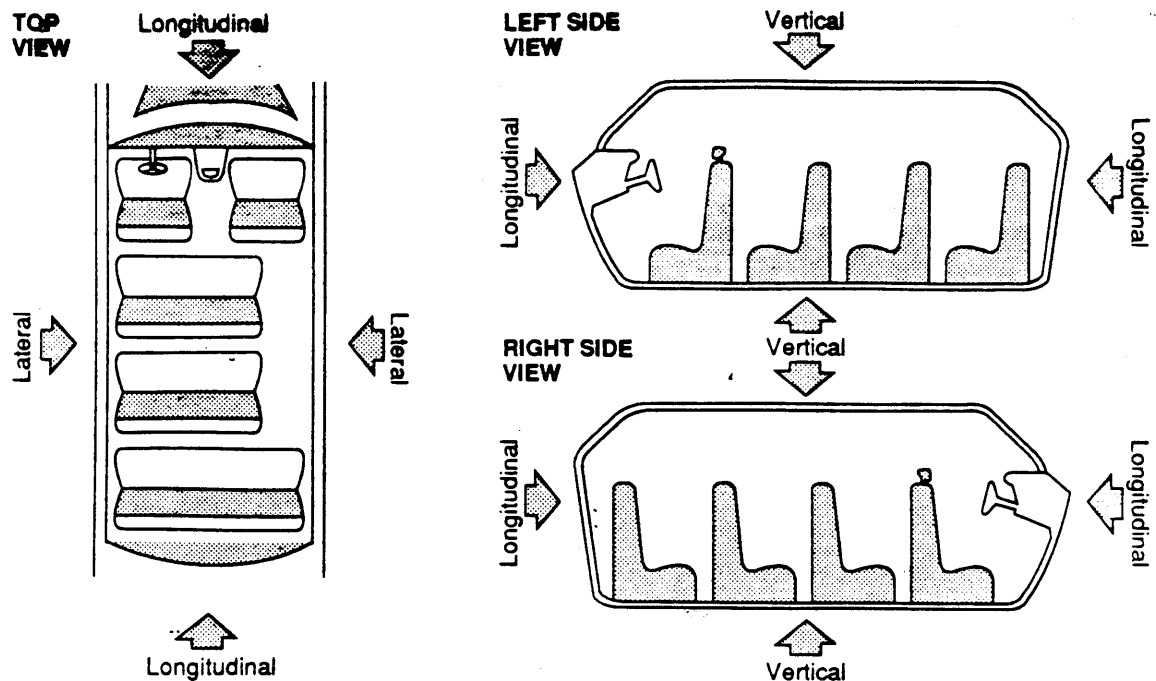
## INTRUSION WORK SHEET

LOCATION OF INTRUSION	INTRUDED COMPONENT	COMPARISON VALUE	-	INTRUDED VALUE	=	INTRUSION	DOMINANT CRUSH DIRECTION
1-1	TOE PAN	20.75	-	16.5	=	4.25	LONG
1-1	LOWER A-PILLAR	19.25	-	16.5	=	2.75	LAT
1-1	FLOOR PAN	23.5	-	22.5	=	1.0	VERT
1-1	LF DOOR SILL - FORWARD	19.25	-	19.0	=	0.25	LAT
1-1	LF DOOR SILL - MID	34.75	-	35.0	=	-0.25	VERT
1-1	LF DOOR SILL - REAR	28.0	-	30.0	=	-2.0	VERT
2-1	LOWER B PILLAR	25.5	-	29.5	=	-4.0	VERT
2-1	UPPER C PILLAR	25.0	-	29.0	=	-4.0	VERT
2-1	FLOOR PAN	43.0	-	41.75	=	1.25	VERT
2-2	FLOOR PAN	46.0	-	41.75	=	4.25	VERT
			-		=		
			-		=		
			-		=		
			-		=		
			-		=
